# FISH BARRIER ASSESSMENT OF FAIR-A-FAR MILL AND DOWIES MILL WEIRS, RIVER ALMOND

Kjersti Birkeland & Alistair Duguid

13<sup>th</sup> July 2015

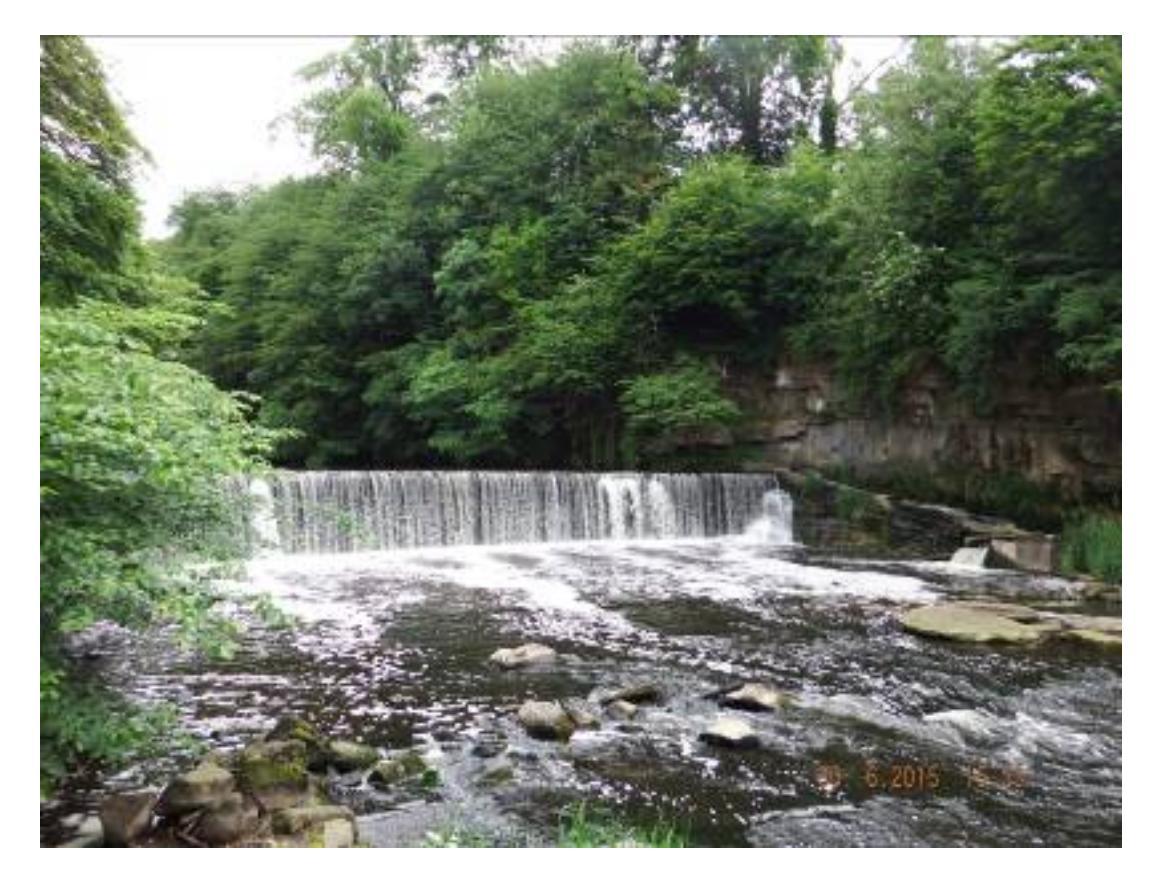
There is a fish pass structure situated at the left bank (looking downstream) of the weir. The entrance is at right angles to the main flow, in a back eddy some 14 metres downstream from the weir face. There seems to be little attraction flow to the fish pass entrance and even during the relatively low flow conditions prevailing during the site visit it would be expected that fish would be attracted to the impassable weir face instead of the fish pass. At best this will delay the time it will take for fish to find the fish pass entrance, but it may result in some fish completely failing to find the fish pass.

*Figure 2:* General view of Fair-a-far weir showing the weir height, and fish pass on the far bank. Note the lack of a clear attraction flow towards the fish pass entrance, and the leap needed to enter the first pool.

The current issues with insufficient depth, excessive turbulence and possible high flow velocity would be best solved by modifications to the fish pass. It is doubtful that small scale works to repair or upgrade the existing baffles will be sufficient given the gradient and length of the channel. The site would seem to lend itself to the use of a technical baffled pass however, either a bottom baffled, Larinier type, or, if that can not be fitted into the available space, then an Alaskan type side baffled pass. A double-flight pass may be needed given the length involved, and the existing large deep pool halfway up the fish pass could be used as an effective resting area between flights. If the lowermost flight were to double back towards the weir toe, this would appear likely to improve attraction to the fish pass entrance, as it would be discharging into the main weir pool, as well as reducing the height of the vertical leap required to enter the fish pass.

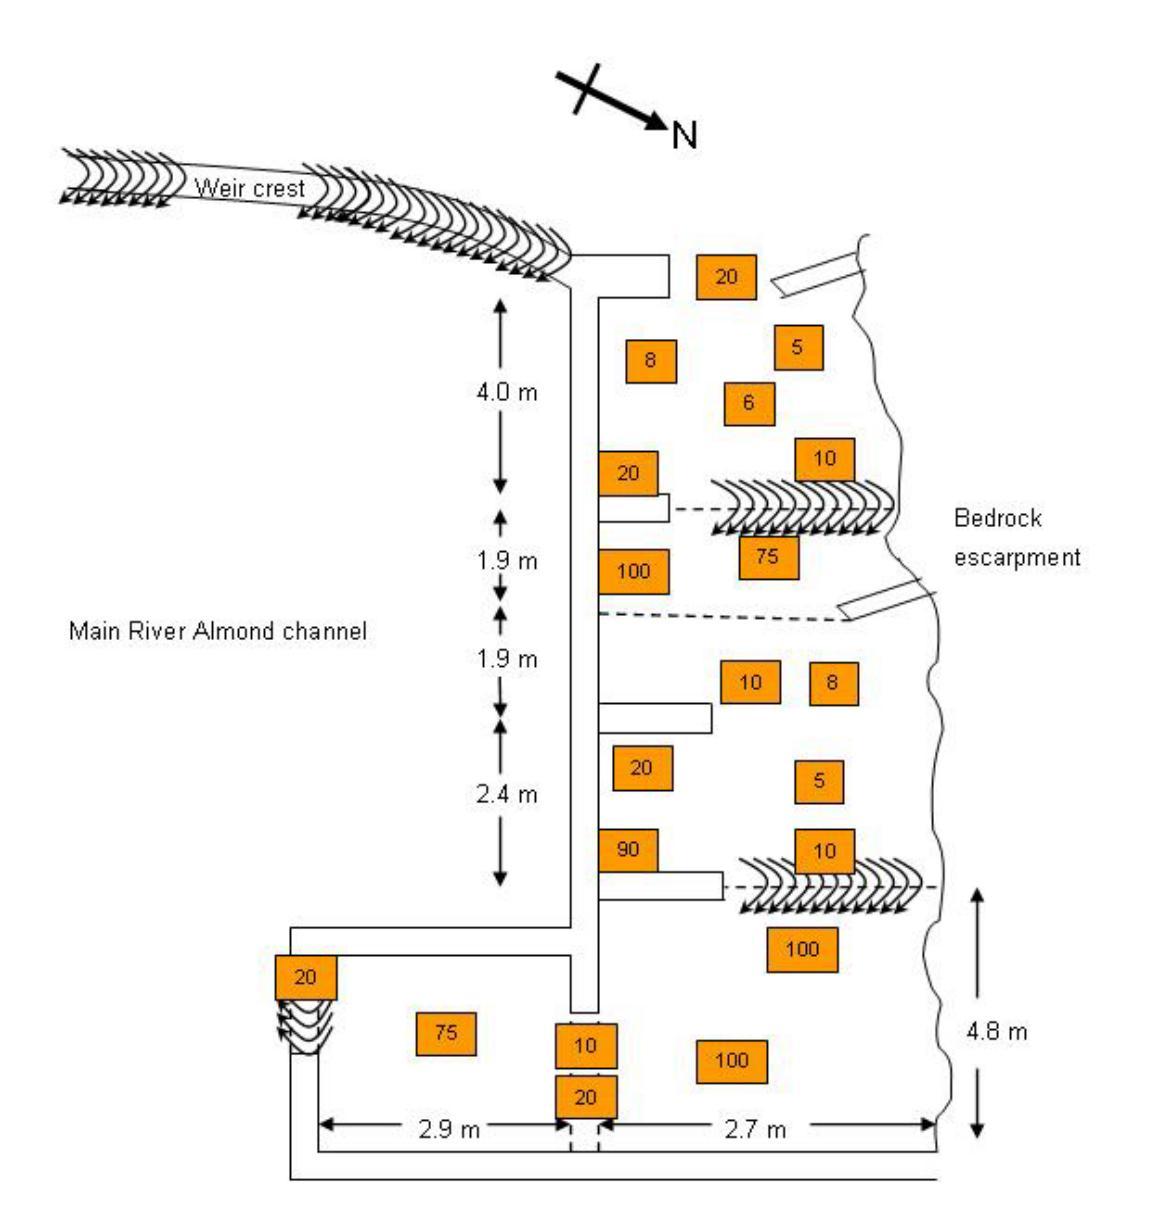
*Figure 3.* Rough plan of the Fair-a-far fish pass. This is not drawn to scale, but key dimensions are shown. Vertical drops requiring fish to leap are shown with arrows. Water depth is given at spot locations in orange boxes. Note the lack of suitable depth in the uppermost section of the pass, which is also shown clearly in the photograph in Figure 5.

Shallow water depths and high velocities were recorded through the sloping section of the fish pass making these sections of the fish pass a major issue (Table 1). Water levels recorded on the day were moderately low (approximately Q80) and the maximum water depth recorded through the sloping section was 10cm, but in places the water depth was as low as 5 cm, and was commonly around 8 cm. These values are at the minimum limit required for a salmon to swim effectively, and result in a high impact barrier score to salmon and sea trout.

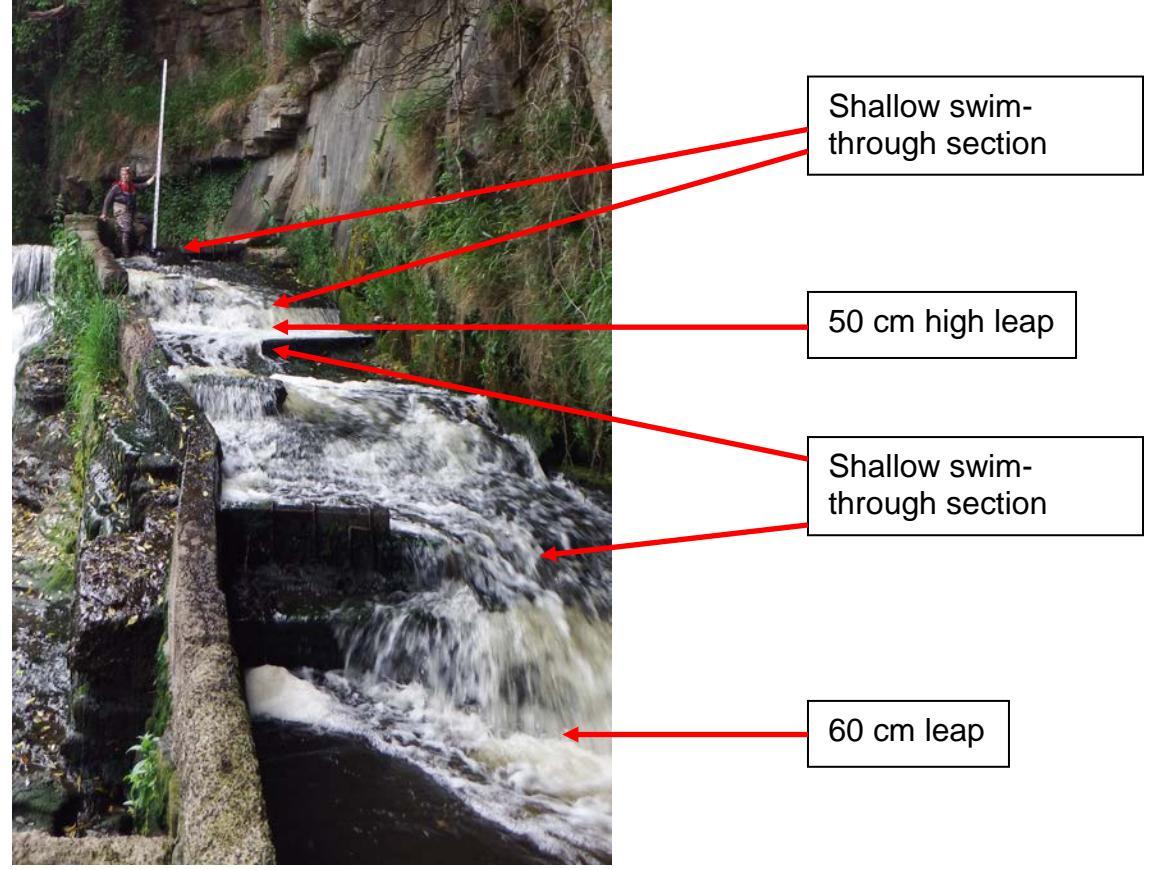
*Figure 4:* The upper part of the fish pass at Fair-a-far. The challenges presented by different sections are indicated.

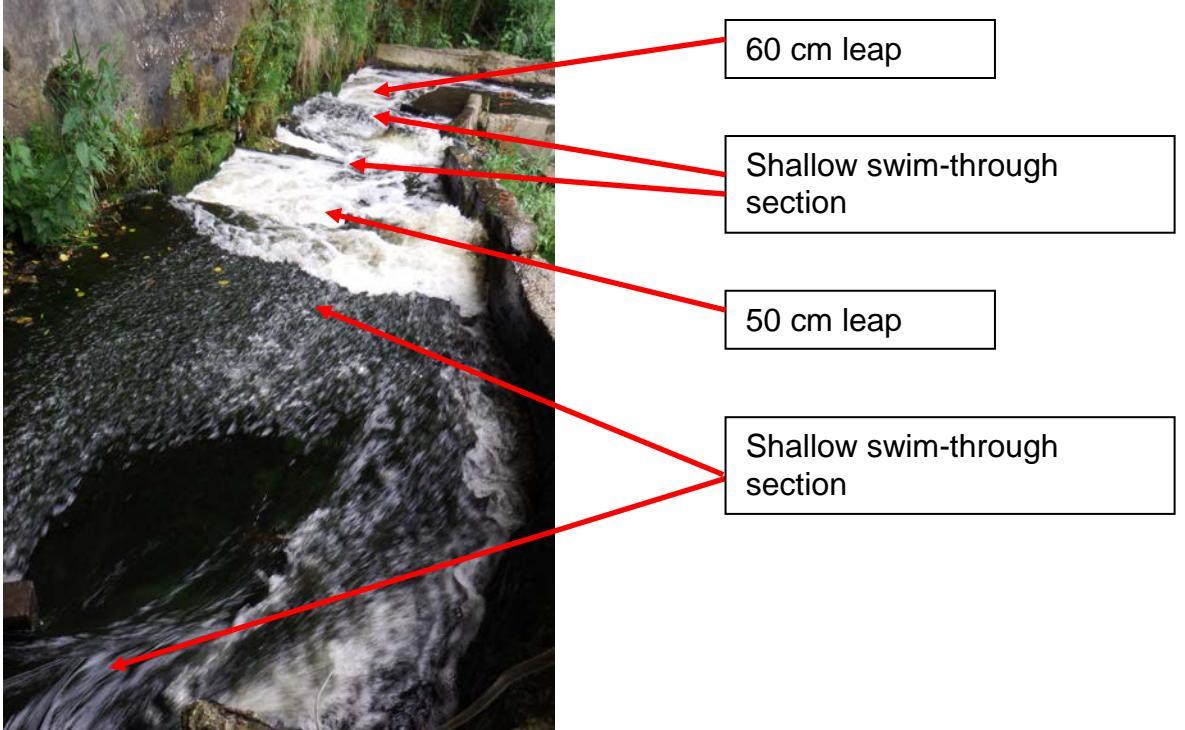
**Figure 5.** The upper part of the fish pass at Fair-a-far, viewed from the upstream end. Challenging sections are indicated, as in Plate 2. Note particularly the upper swim through section, which is extremely shallow and fast flowing.

The water velocities observed throughout most of the fish pass would be expected to be manageable for salmon and trout, although they would be challenging in the upper section, where speeds approached 2.5 m/s. This is on the boundary between Low and High Impact barrier, and within the value of 3m/s used to define a passable obstacle for salmon and sea trout (Table 1).
