# **Dowies Mill Weir**

Structural Inspection

City of Edinburgh Council

29/10/2018

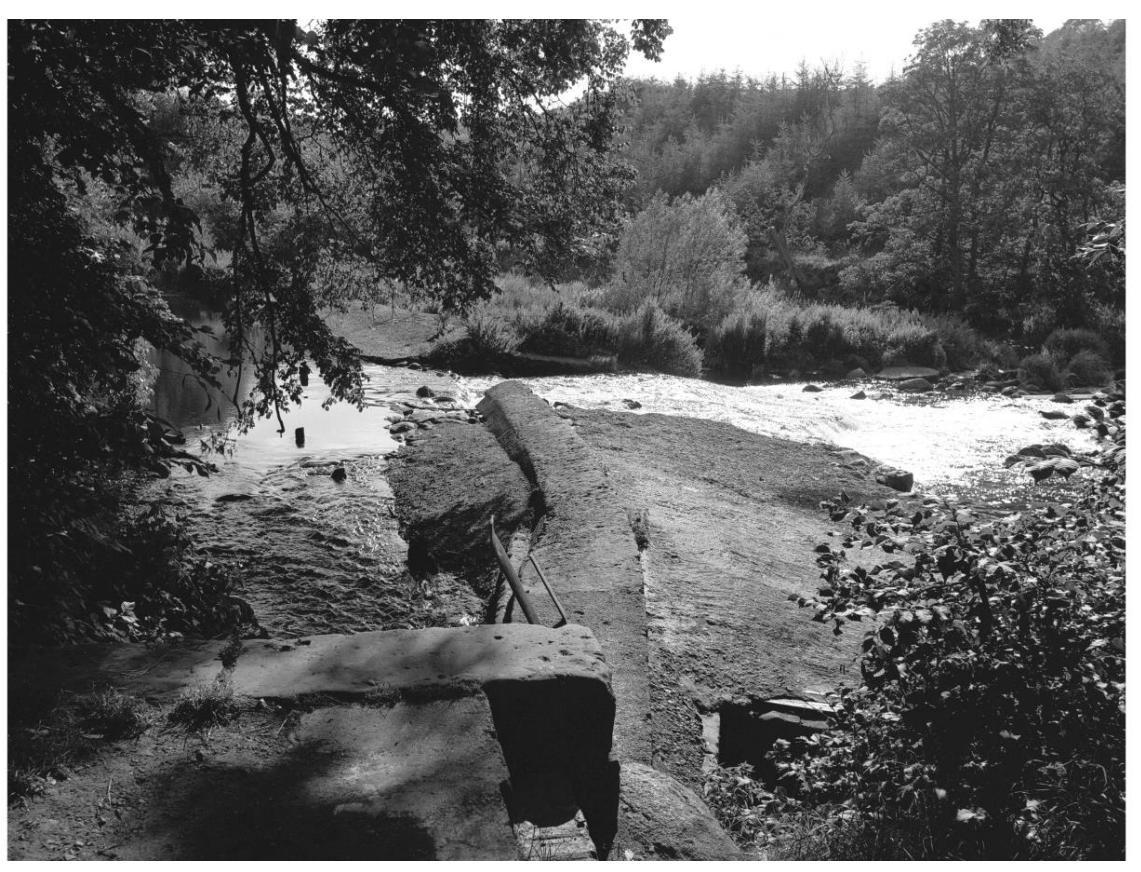
HES Archive Photograph 1975

The earliest known photograph of the weir is held in Historic Environment Scotland (HES) archives and records indicate the photograph was taken in 1975. In that photograph (shown overleaf) the weir is breached around the middle of the river channel and there appears to be a concrete apron slab, both on the shallower pitched downstream face and steeper pitched upstream face. In the foreground, there is a raised concrete sill built off the top of the weir, forming the crest. A straight drop weir was subsequently constructed (existing today - see photograph overleaf) and we think this new section of weir was built across this breach, recorded in the photograph taken in1975.

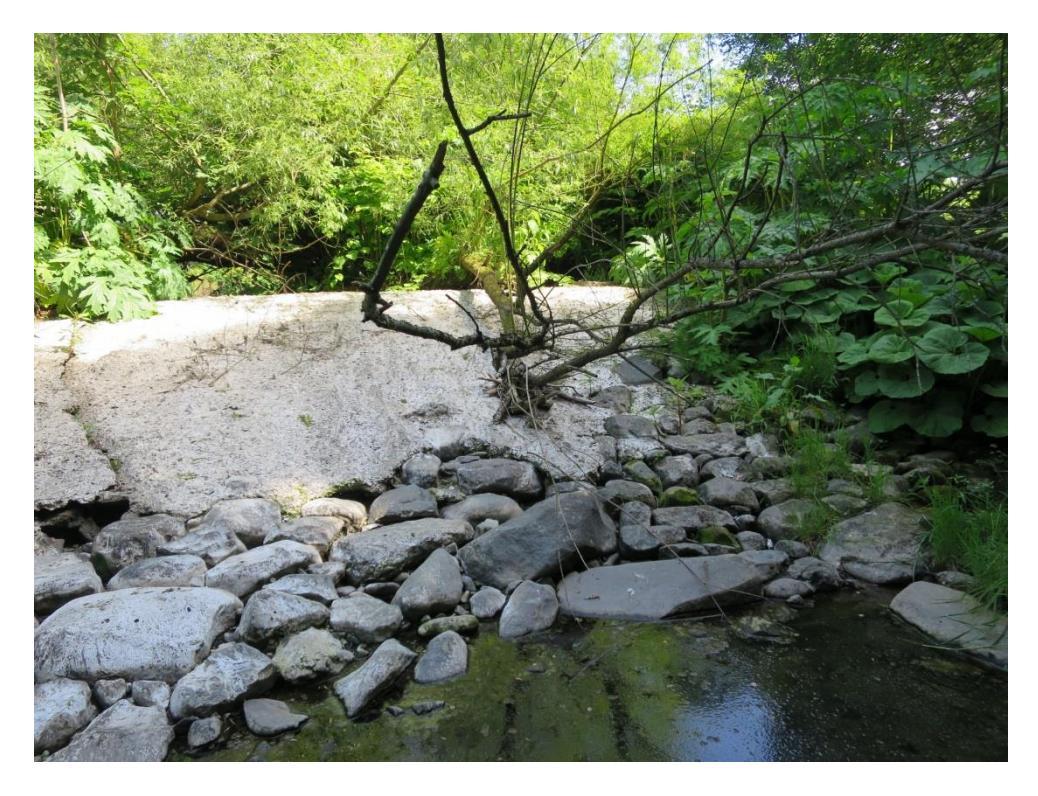
This construction exists to the east and west of the straight drop weir. The western broad crested weir is considered to be in fairly poor condition with the downstream toe being significantly eroded by river flows. This lower section has fragmented with stone material dislodged and washed downstream, the lower part of the concrete apron slab is now missing. Inspection revealed some significant undercutting beneath exposed bottom edge of the weir. General examples of these defects are shown in Appendix A - Photographs Nos 2-6 incl and 11-13 incl.

Photograph No2 – General View – weir downstream face at left hand bank (west end section)

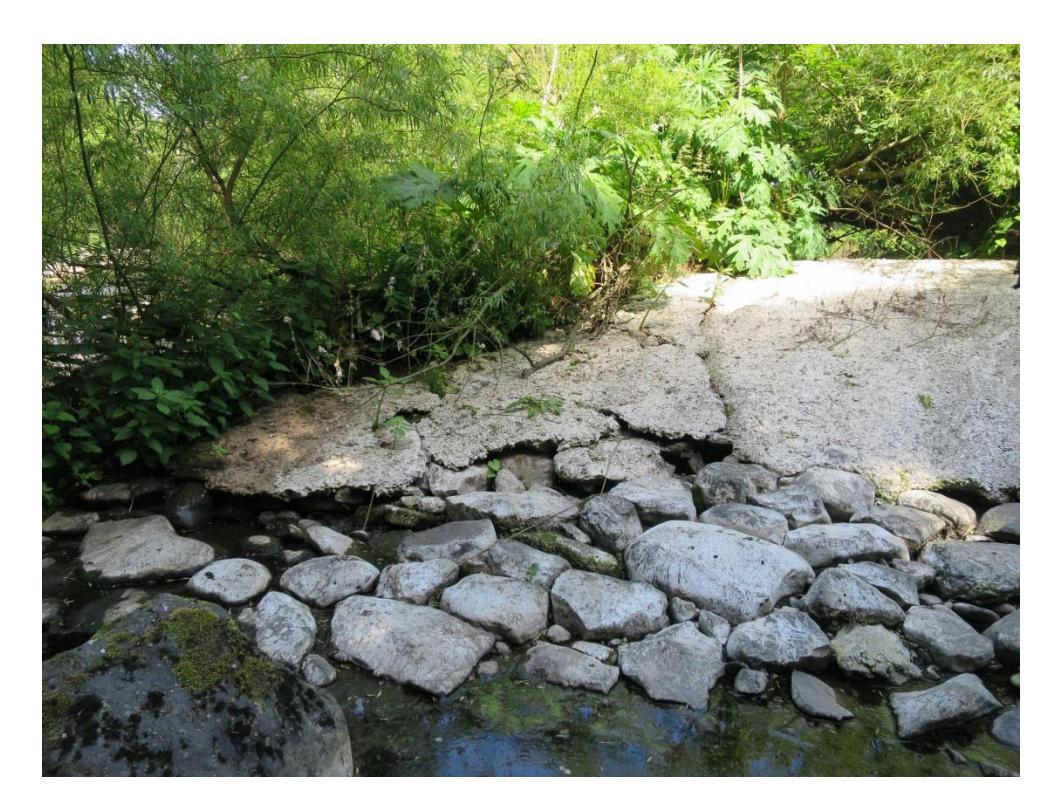
Photograph No3 – General View – weir downstream face near right hand bank (west end section with vegetation established on weir face)

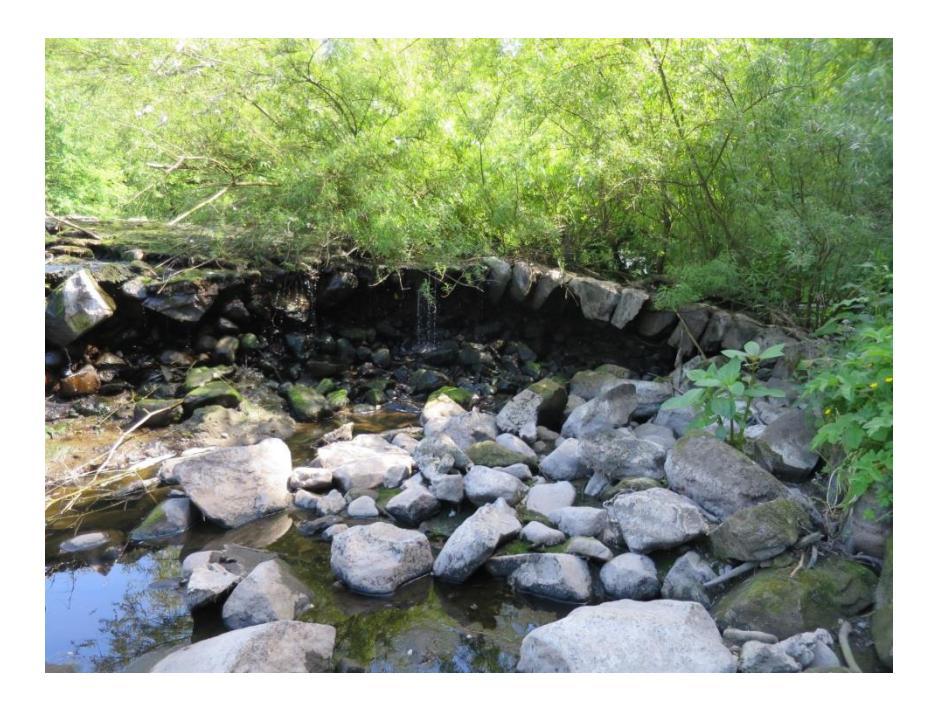
The weir is thought to have been first established in the early 17<sup>th</sup> century to impound water for Dowie's Mill. The original weir construction and cross sectional profile is not known however it is likely to have been wholly constructed in stone, with locally recovered boulders/cobbles forming an inner core. The weir crest could have been formed with dressed masonry blocks and the upstream and downstream faces of the weir sloped down to the river bed with an outer layer of semi-dressed (or simply selected and packed) stone pitching. There is still evidence of pitching stone, although what is visible today may not be the original construction but a later modification - see Photograph No4 in Appendix A.

Photograph No4 – General View Weir West End Section Downstream Face (scour and heavy undercutting beneath stone pitching)

**Priority 1**- Stabilise toe of existing weir with mass concrete and larger size boulders (in addition to importing new stone, some may be retrieved from the riverbed immediately downstream)

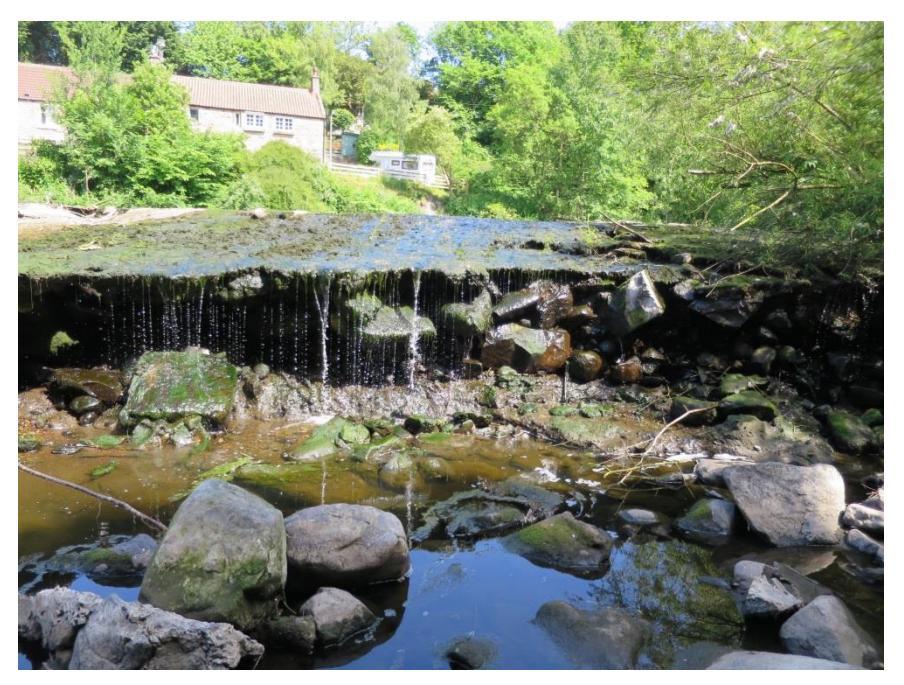
Photograph No5 – Middle Section General View Weir Downstream face (scour and deep undercutting along toe of downstream face)

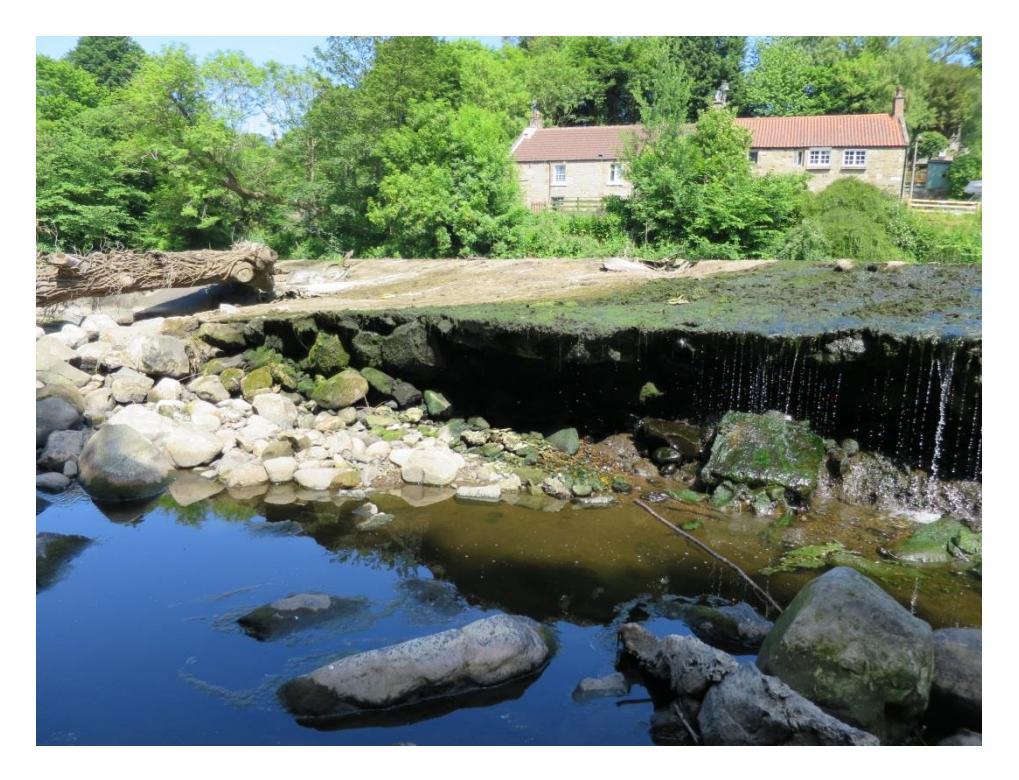
Photograph No6 – Middle Section General View Weir Downstream face (scour and deep undercutting along toe of downstream face)

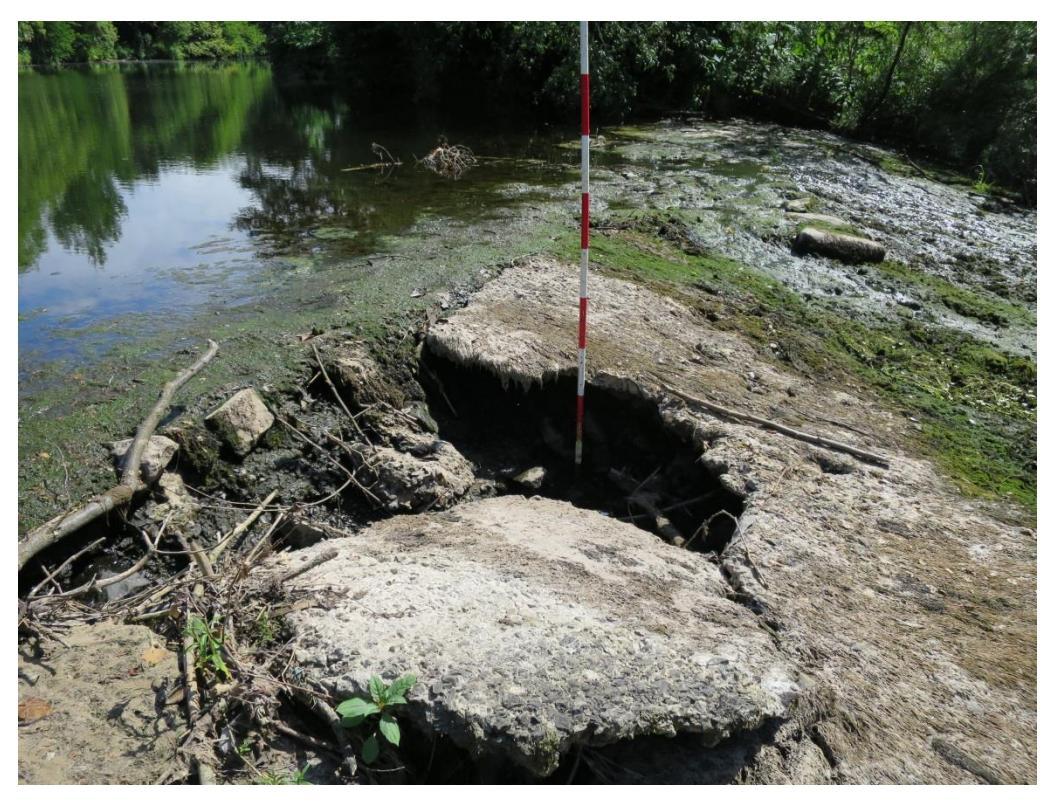
In one localised area, the concrete apron slab was found to be partially collapsed, with voiding below -see Photograph No 7 in Appendix A.

**Photograph No7** – Middle Section top of downstream slope Damaged section of concrete apron and scour hole (approx. 2mx2mx0.5mdeep)

**Priority 2**- Infill the localised void on the downstream face where concrete apron has collapsed (Photograph 7)

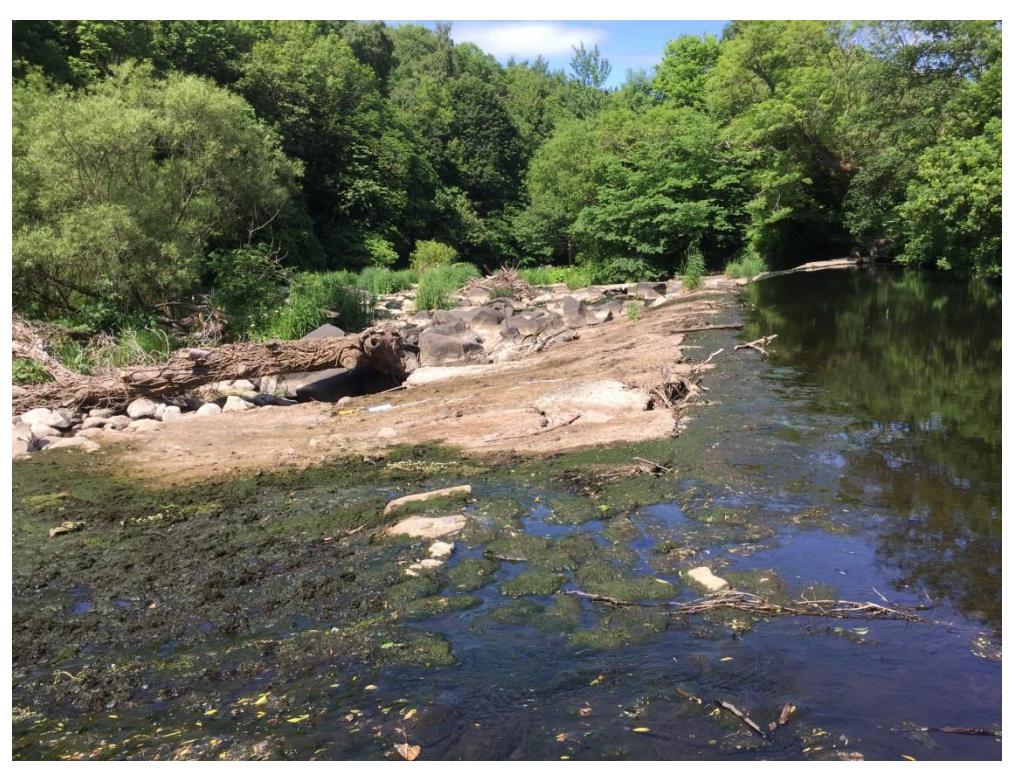
**Photograph No9** – Middle Section- general view looking towards right hand bank along weir crest (Note: large tree trunk washed downstream and resting on boulders immediately downstream of weir)

- Remove large tree trunk on weir downstream face
- Rock works to reform weir profile (approximate volume 15m x 3m in plan x1m depth)
- Reinstate rock armour stone along downstream face to reform toe profile (approximate volume 4mx4m in plan x 1m depth)
- Concrete infill to voids between rock/boulder repairs (approximate volume 48m<sup>2</sup> area x 0.6m depth)
- Surface capping repairs to damaged concrete apron (approximate volume 16m x 6m in plan x0.25m depth) include for dowelling into the weir structure (say 1.5m c/c throughout)

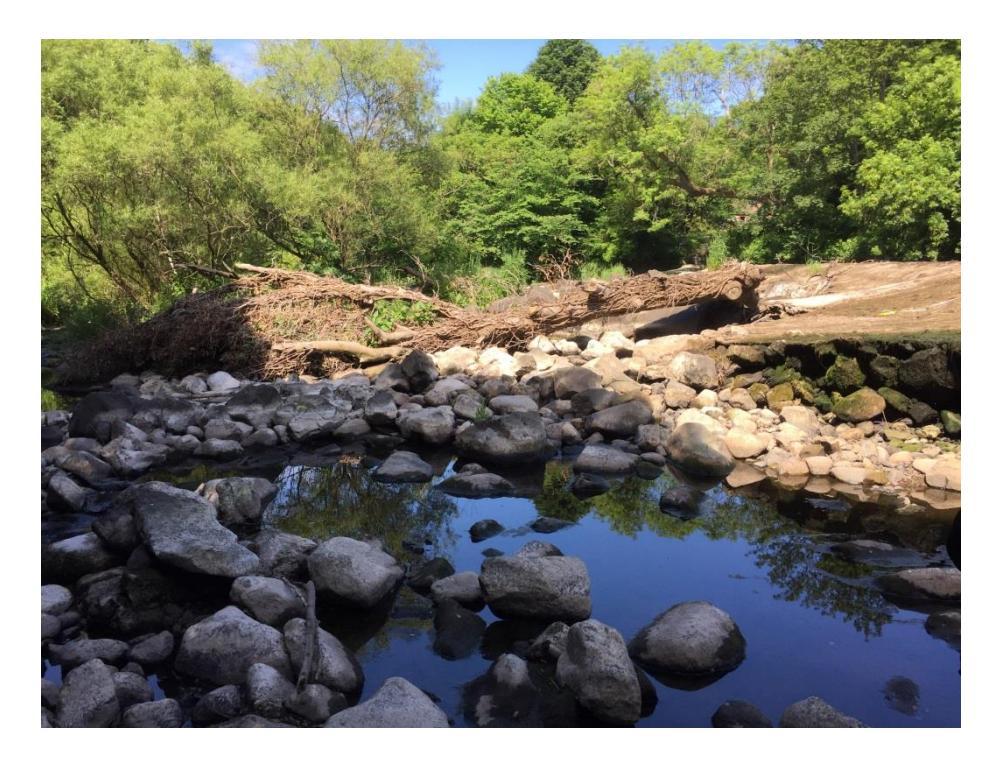
Photograph No10 – Middle Section general view downstream of weir - loose boulders and cobbles. Water in foreground is largely river infiltration through weir. There is a substantial tree trunk downstream of weir, washed over the weir in heavy flow conditions)

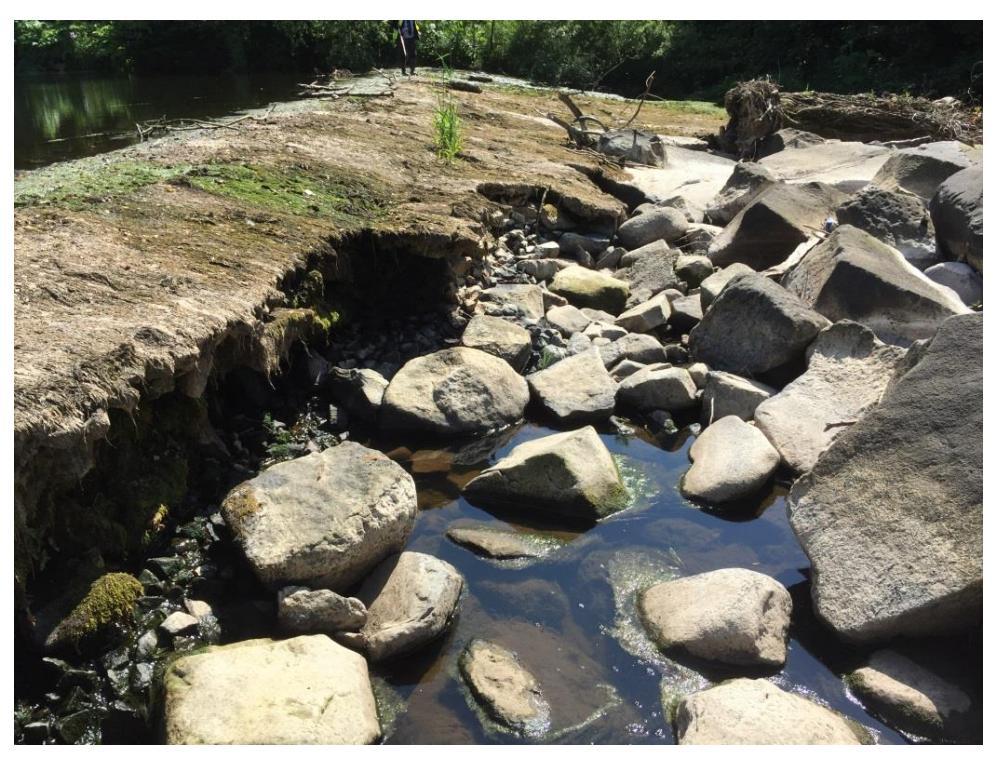
Photograph No11 – Middle Section- general view of weir downstream face (looking towards right hand bank) Concrete apron damaged with dislodged boulders at downstream face

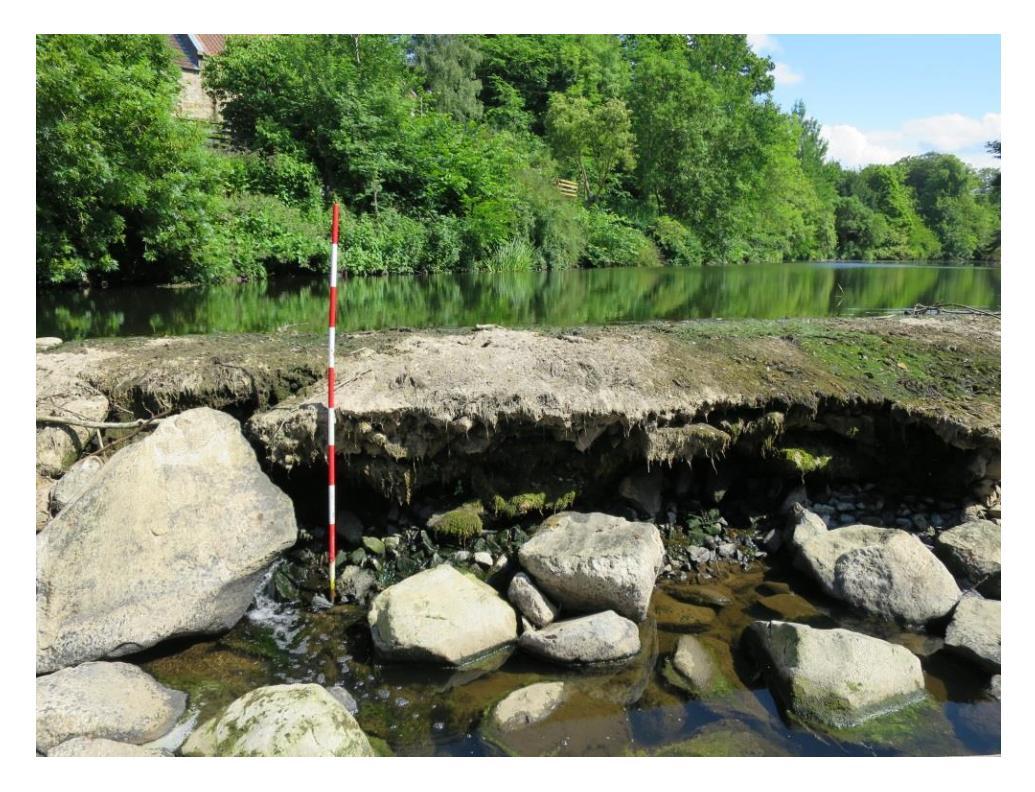
Scour of downstream slope undercutting concrete apron, note running water through structure near ranging rod) weir height is approximately1.4m at this position)

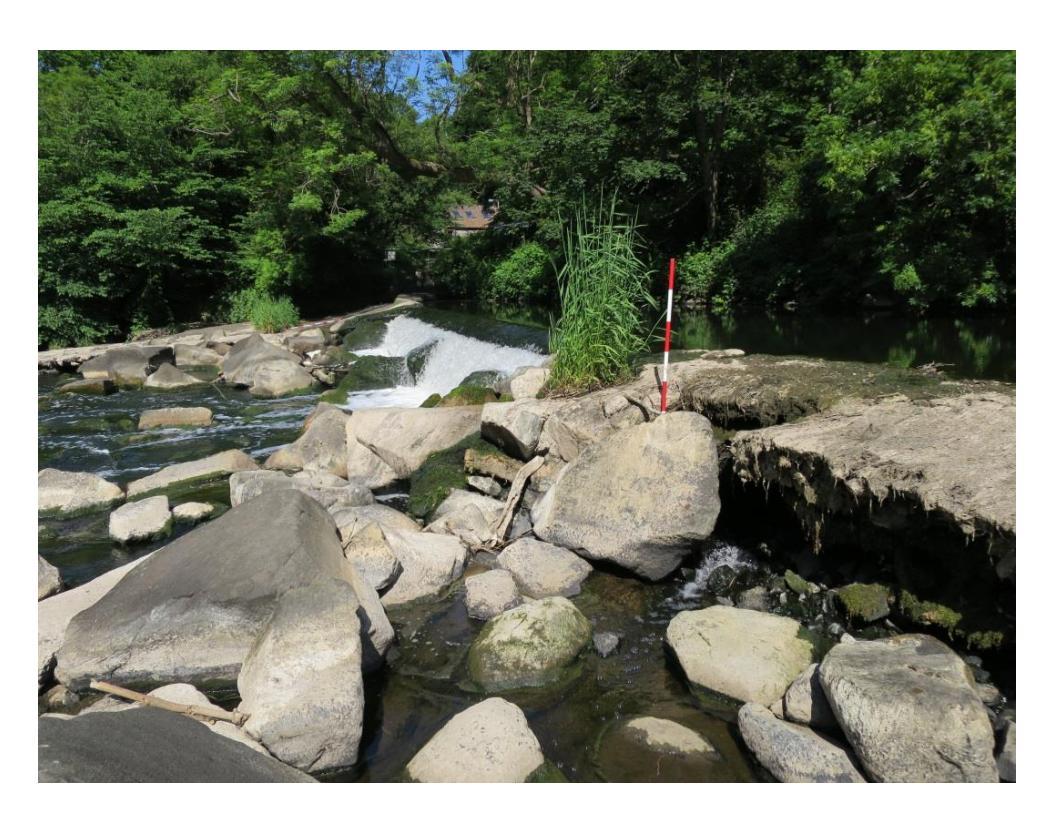
The masonry crest blocks appear to be set level with uniform water flows over the weir. In this particular location, there are some large boulders in the watercourse immediately downstream of the masonry weir which form obstructions to flow.

Photograph No13– Middle section view looking towards right hand bank- large boulders immediately downstream

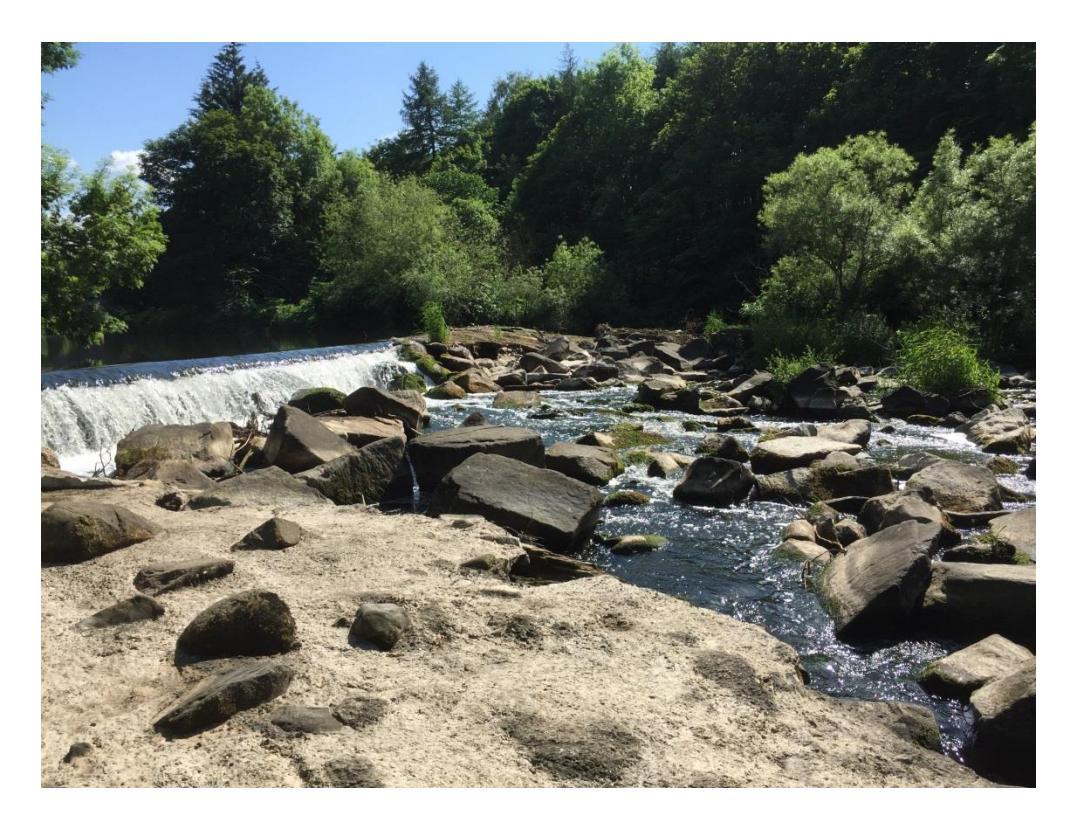
Photograph No14– Drop Weir Section view downstream of weir- boulders scattered on riverbed- some partially dressed masonry visible in foreground (remnants of previous weir construction possibly at location of drop weir)

Move local river bed boulders out the base of the channel immediately downstream of weir (approximate 14m x 6m plan)

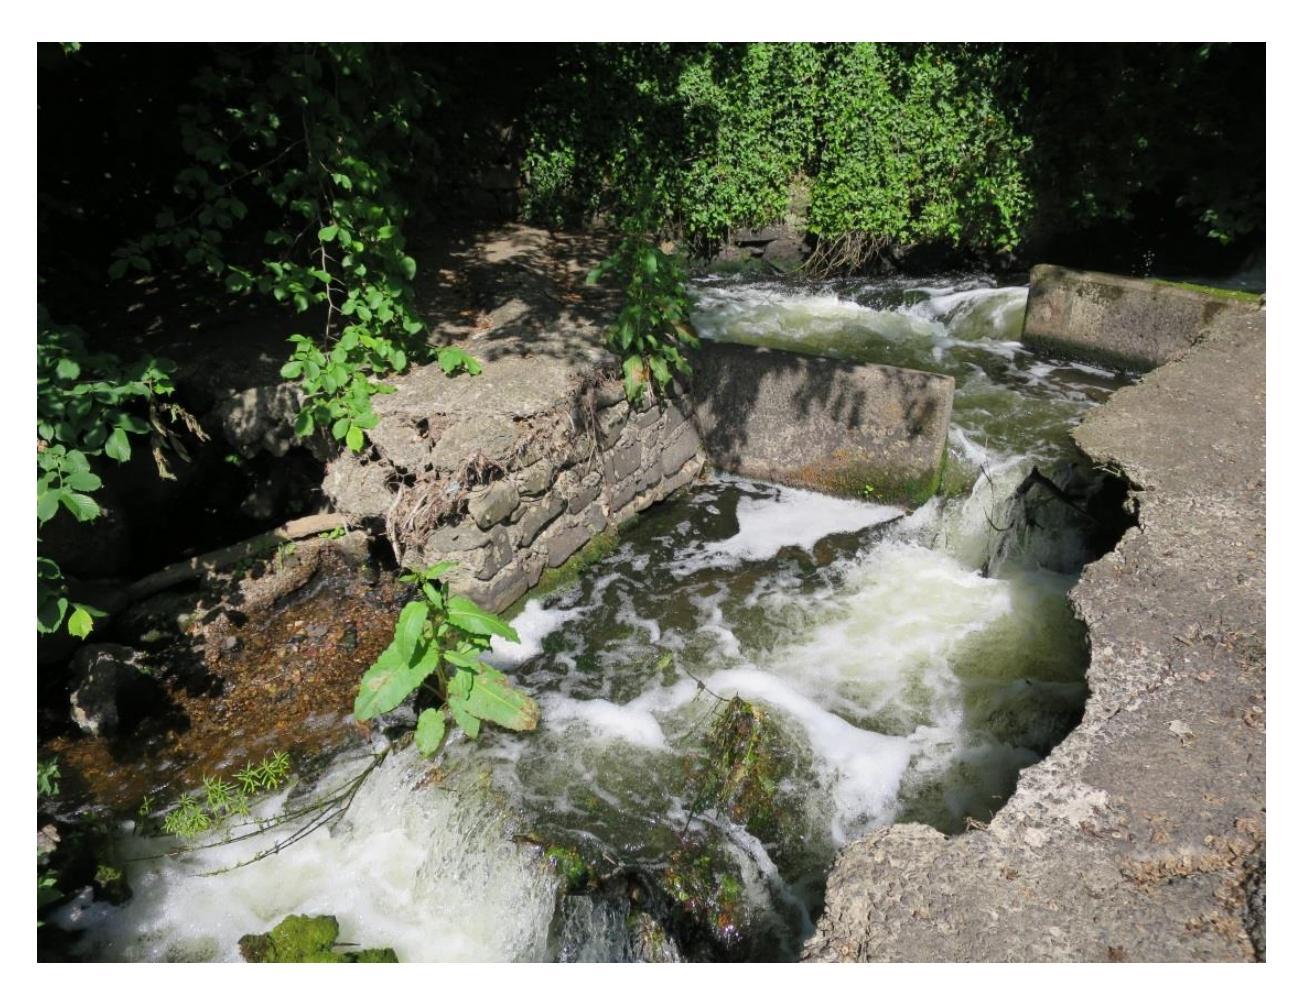
Photograph No23 – By-pass channel (fish pass) downstream at entry into the main watercourse Note: scouring/undercutting beneath concrete apron and masonry side wall

Infill undercut sections with mass concrete to shore up/protect existing stone wall (estimated volume 12m<sup>3</sup>)
